Manager's Report

May 24, 2016

By Rob Williams, VillaRosso Manager

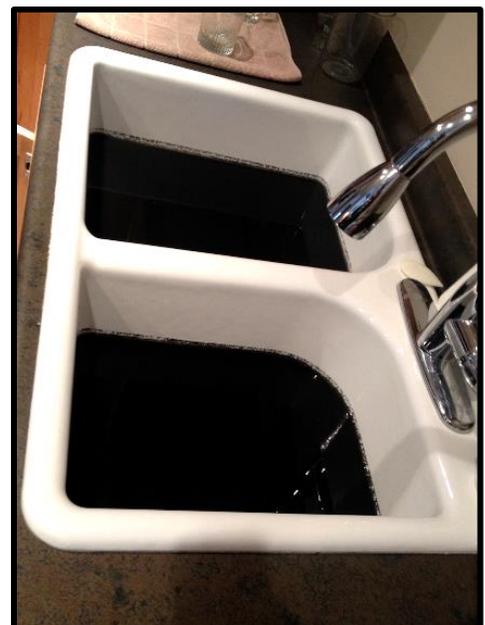
Kitchen Stack Jetting

Jetting of the kitchen stacks happened March 30, 31 and April 1 as scheduled. Access to each stack was from the 6th floor kitchen drain behind the trap. Temporary plugs were installed in two openings under the sink of every unit below (the top opening used for the dishwasher drain and the "air gap" opening below that which is a designed anti-siphon feature). Some stacks experienced a certain amount of "blowback" which filled the lowest sink with oily-black almost pudding-like liquid which had been scoured off the inside of the pipe. This clearly showed the advantage of utilizing this high-pressure water jetting procedure over just cabling the line in the traditional sense.

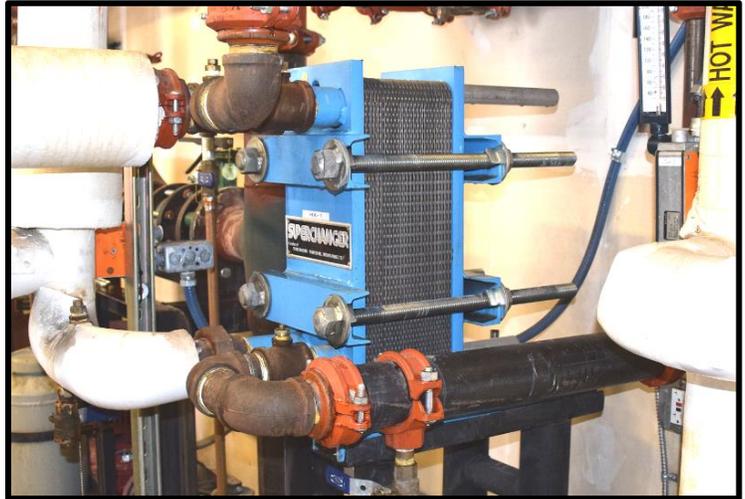
Flat Plate Heat Exchanger

I came in on Saturday, April 23, and spent the day working on the heat exchanger replacement (the blue device in the photo). The procedure went off without a problem. The old plates definitely were ready for replacement as the rubber gaskets were hard and crumbly and there were many pieces laying in the bottom ports of the unit (and of course the unit leaked seriously). The new plates were delivered in the order of installation and went in without any fuss. One advantage to doing it with factory rebuilt plates is they can be installed with no downtime (Design Mechanical estimated 5 days for the heating/cooling system to be shut off). The new plates are holding well and there haven't been any leaks since, even when the boiler shuts down due to warm weather and the pipes cool off, which is when the heat exchanger leaked its glycol all over the floor.

I did charge the building for my time but the end result is a significant savings over the other contractors cost. An extra advantage in doing it "in-house" is the plates themselves are factory re-fabricated units and essentially are brand new, a substantial improvement over scraping off the old gaskets by hand with a chisel and gluing new ones back on in the field. Also, the old plates can be sent to the factory to be refurbished to a new condition for the next servicing at a much reduced cost.

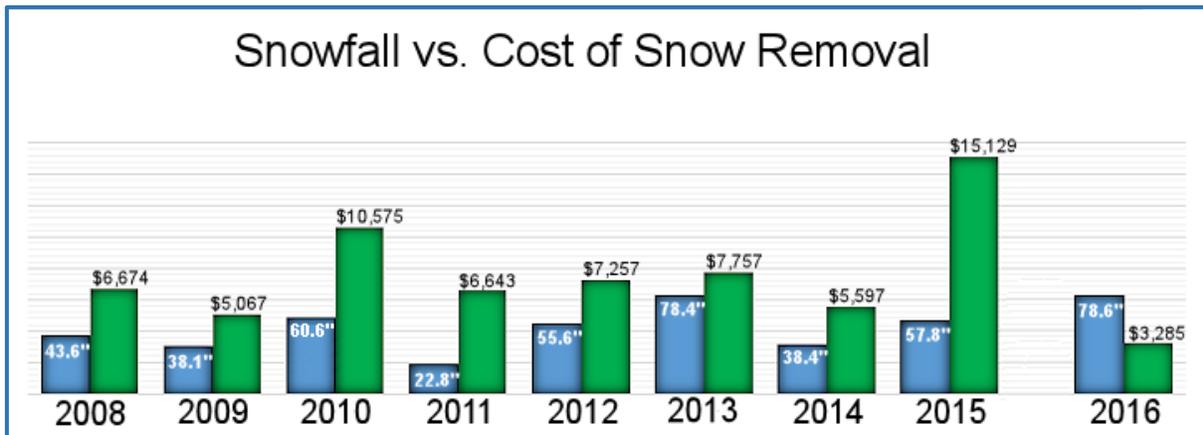
Snow Removal Services

This season we tried a new snow removal contractor, Environmental Designs, in place of Snow Management Services, a division of Groundmasters, which was used for many years in the past. I felt that we were paying way too much for this service and as you can see from the chart, there is a marked difference in the cost for this year over the last nine years. In fact we had the snowiest year since 2008 but paid the smallest amount for snow removal, nearly half of what was paid in the least costly year in that time period.

Blue bars denote snowfall in inches, green bars reflect the cost of snow removal in dollars. Data on snowfall comes from the National Weather Service except for 2016 where it comes from Channel 4 News (since the National Weather Service has not posted snow totals for this year yet). The cost of each year's snow removal is from VillaRosso's accounting software (QuickBooks).

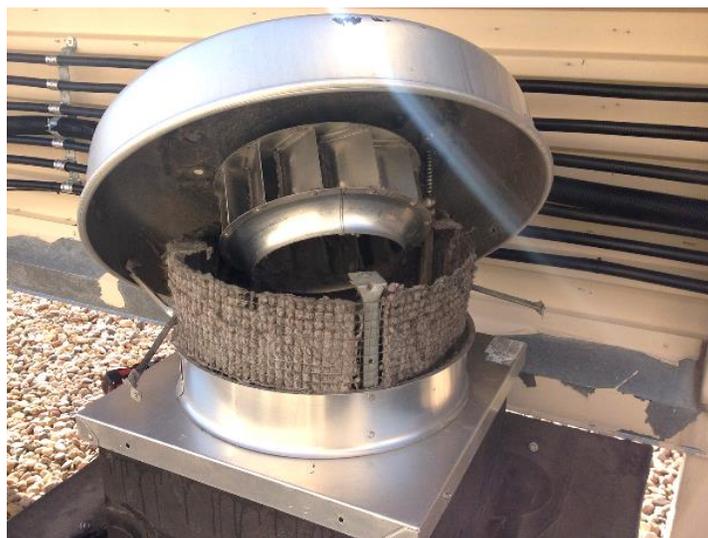
Clogged Exhaust Fans

Exhaust fans that run continuously on the roof become clogged over time with lint from dryers. Most of them show some accumulation but are not significantly obstructed. This #8 fan was rather packed with lint and what looked like animal hair. I had to disassemble the whole thing just to get the screen out. Other fans are only minimally blocked at this time but will need to be cleaned at some point in the future.
