# Manager's Report

September 27, 2016

By Rob Williams, VillaRosso Manager

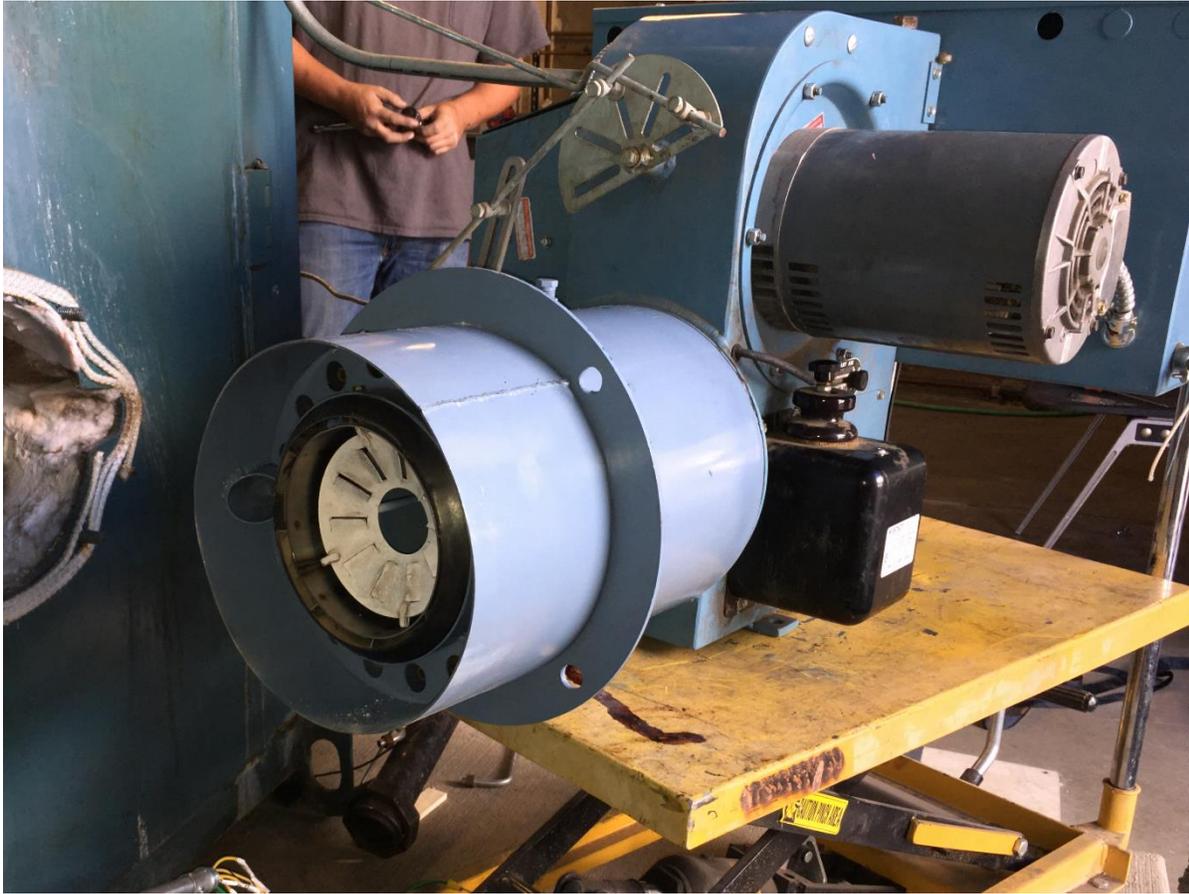
**Figure 1 - The newly refabricated cylindrical section of the power burner that is inserted into the boiler. The end that is designed to induce the complete combustion of fuel has been restored.**

Frost Line Mechanical installed the new Power Burner on September 16. It was none too soon as nights were getting a little cool, sometimes down to the high 40's.

The boiler fired up without too much difficulty and all systems were operating within normal design parameters.

A combustion measurement was performed which showed good efficiency. Time will tell how much improvement in fuel efficiency is realized but just from the sound of it, there is a more robust roar when it is operating than we had before. I'm not sure if that means anything or not.

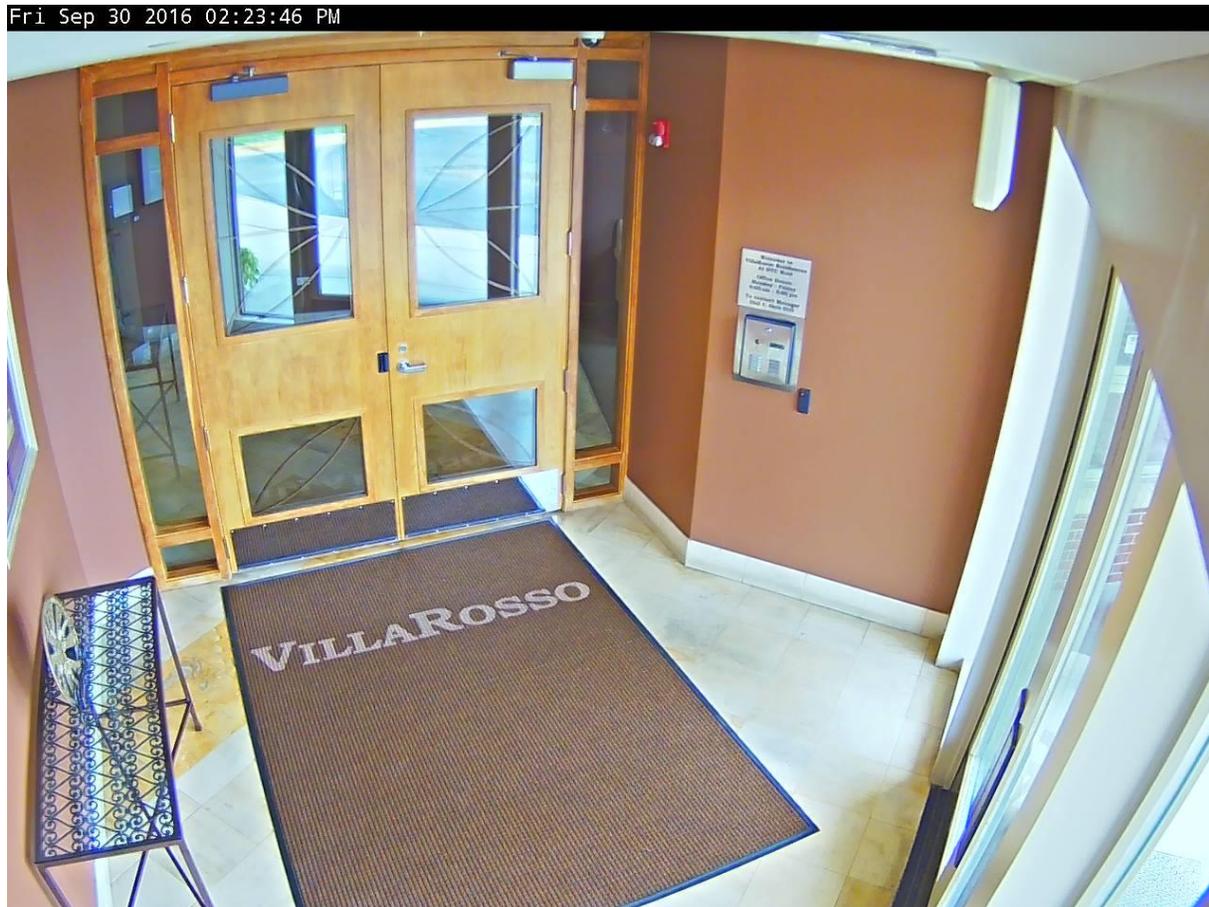
This image of the front entry is from a new IP camera I installed in the vestibule. The view faces the door and entry system, away from the often bright light of the windows. The camera has many advanced features including multiple video streams at different resolutions, among other things. My idea is to try this equipment out as a “proof of concept” type of thing and also to educate myself on the latest technology in the video surveillance industry. That way I can advise on the best possible choices for an upgraded surveillance system to replace or augment the existing one.

The highest resolution of this camera is 1920x1280 out of 9 configurable outputs. 1920x1280 is higher than a 1080p HDTV which is important when you enlarge a portion of a picture to identify something or someone. (The resolution in the existing system is somewhere around 252x240). This high resolution is actually too high for this entry and so it will default to the next lower 1280x960. The high resolution does take up a lot of bandwidth. This makes it suitable to the in-house network and a computer directly attached to the internet, but the lower resolutions will deliver a very good picture and reduce the amount of bandwidth associated with downloading a video over wifi, and especially mobile phones. The resolutions are user selectable from a drop-down list on the upper corner of the application.

- Support for “Edge Storage” to an onboard micro SD card so each camera can store their own video outputs.
- Support for recording to dedicated network-attached storage device (NAS) – eliminating the need for a DVR or NVR.
- Robust on-board analytics including built-in motion detection, multiple tampering alarms, masks and custom views, which also eliminates the need for a DVR or NVR.
- POE which makes it easier to wire up.
